Outline

- I. Demagnetization of permanent magnets
 - ✓ Example of demagnetization
 - ✓ Steps towards solutions
- II. Dosimetry inside of the Storage Ring
- III. Study of the damaged materials and equipment in the Storage Ring

I. Demagnetization of Permanent Magnets

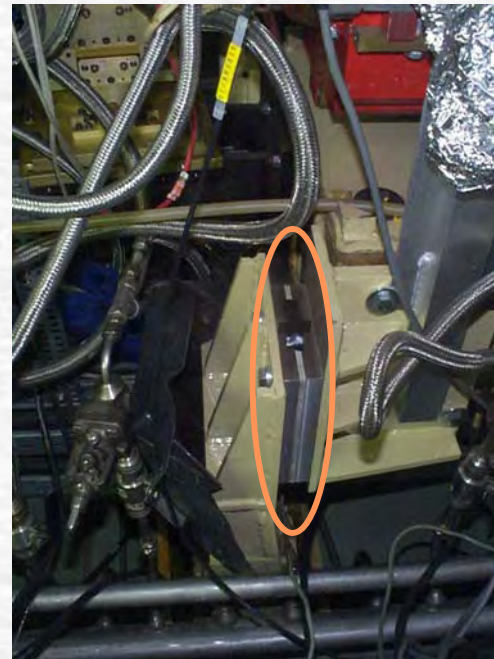
- ViscoElastic Materials (for Damping Links)
⇒ A 2 mm lead protection is reducing the dose by a factor of 100.

VEM are very sensitive to radiation aging
